Safety Awareness Notification

No. 19, 24 August 09

Damage to Tyre Handler – Broken Rotation Pin

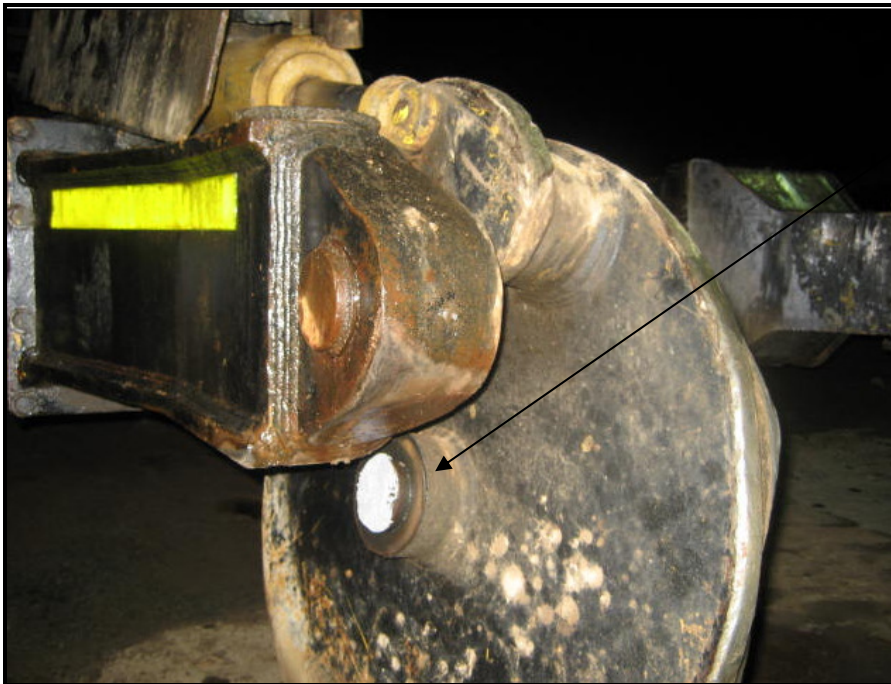
Whilst removing flange and bead seat band (BSB) out of a 40.00R57 dump truck tyre the RHS rotation pad became jammed between the flange & BSB. The tyre fitter has moved the handler arms from side to side and in doing so the rotation pin has broken.

- The tyre fitter did not check prior to lifting that the BSB was free from the bead of the tyre.
- The tyre handler pads were incorrectly positioned between the BSB and flange.
- The Otraco Best Practice (OBP) does not describe what to do if the Tyre Handler Arms become stuck and a Job Hazard Assessment (JHA) was not completed when this change in the task was identified.

Broken Rotation Pin

- Discuss at all toolbox meetings the importance and findings of this incident highlighting that care must always be taken when using tyre handler/forklift attachments and that force should never be applied to the tyre handler/forklift arms.
- OBP-002 has been amended to include that the BSB must be checked ensuring that it is free from the bead of the tyre prior to using the tyre handler/forklift attachment to lift. The revised OBP-002 is to be discussed with and reviewed by all personnel on site.
- Communicate to all personnel on site the importance of following the OBP or appropriate safe work procedure for the task, and reinforce that whenever the task deviates from this that the job is stopped and a JHA is completed.
