Fatal Haultruck Tire & Rim Disassembly during a Tire Change

Classification: Fatality Injuries: Four fatalities
Otraco incident: No

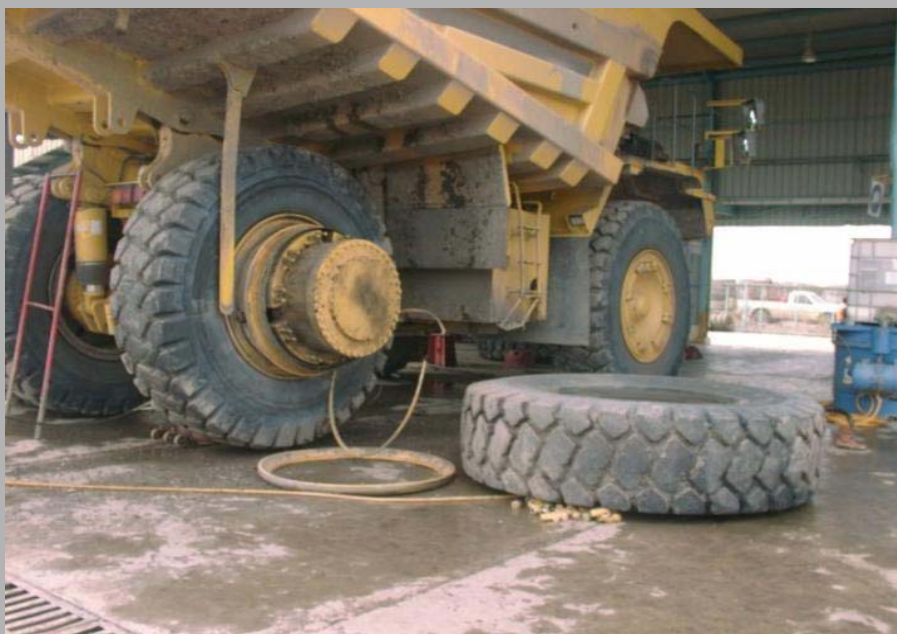
Three tire fitters and a workshop assistant were changing the right outside rear (position 6) tire on a Komatsu HD785 haultruck at a tire workshop on a minesite in South Kalimantan, Indonesia.

As the tire fitters were attempting to remove the wheel cleats holding the right rear tires in position, there was a sudden release of inflation air, presumably from the right inside rear (position 5) tire.

The outside (position 6) tire and rim assembly was propelled off the wheel hub. The four workers, who were all facing the sidewall of the tire, were hit by the tire and rim assembly as it flew sideways off the truck.

Reports indicate that the right outside rear (position 6) tire was at least partially deflated prior to removing any wheel nuts.

The Komatsu HD785 truck is fitted with demountable rims (i.e. rims attached to the truck by a cleat system rather than being retained by a wheel disc). Under AS 4457, an Australian Standard dealing with off-highway rims, **both** right rear tires should be deflated, to a maximum inflation pressure of 35kPa (5psi), prior to loosening any wheel nuts from this dual assembly.

It seems likely that the inside (position 5) tire had not been properly deflated prior to the wheel nuts being loosened. **While this appears to be the case, it now seems probable that it was the outside (position 6) assembly that failed – indicating inadequate deflation of the position 6 tire. Otraco's standard procedure is TOTAL deflation of both tires.**

- When changing a tire fitted to a demountable rim, ensure that the tire (both tires in a dual assembly) is deflated to a maximum pressure of 35kPa (5psi), but preferably totally deflated, before loosening any wheel nuts.

- Use a tire manipulator, forklift, etc. to press against the wheel assembly, holding it firmly in position, as wheel nuts are being removed.
