## Incident Notice

No 26/07, 28 May 2007

### Incident: Faulty Rim Jammed on Wheel Motor

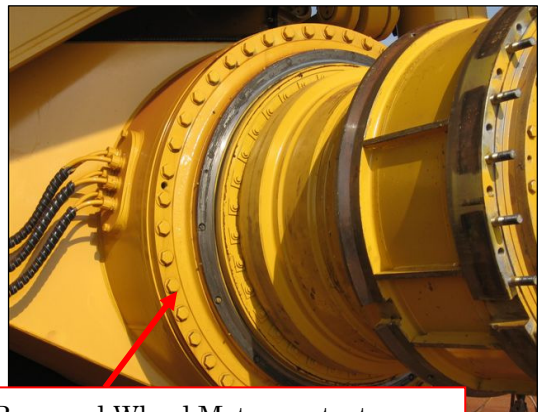
Upon inspection of the wheel motor it was discovered that the position 4 rim assembly was jammed up against the wheel motor causing damage to the wheel motor and rim. The faulty rim was changed out immediately. It was found that the rim width measured 924 mm; the maximum allowable rim width is 905 mm.

Rim Base and Wheel Motor contact area.

- Electric drive trucks with demountable type rims are particularly susceptible due to small clearances between wheel assembly and wheel motor. New or reconditioned rims should be checked upon receipt of the rims on-site and again prior to fitment for the correct rim width using specifically designed rim width gauges.
- Tyre serviceman must ensure that there is adequate clearance between the back section of the rim base and wheel motor prior to finishing the tyre change as specified in safe work procedures.
- New tyre serviceman note pads incorporating some technical information, Take 5 instructions and a tyre and rim checklist and instructions will be distributed to all sites.
