## Incident Notice

No 02-08, 20 Feb 2008

### **Incident: Lock Ring Pinches Finger**

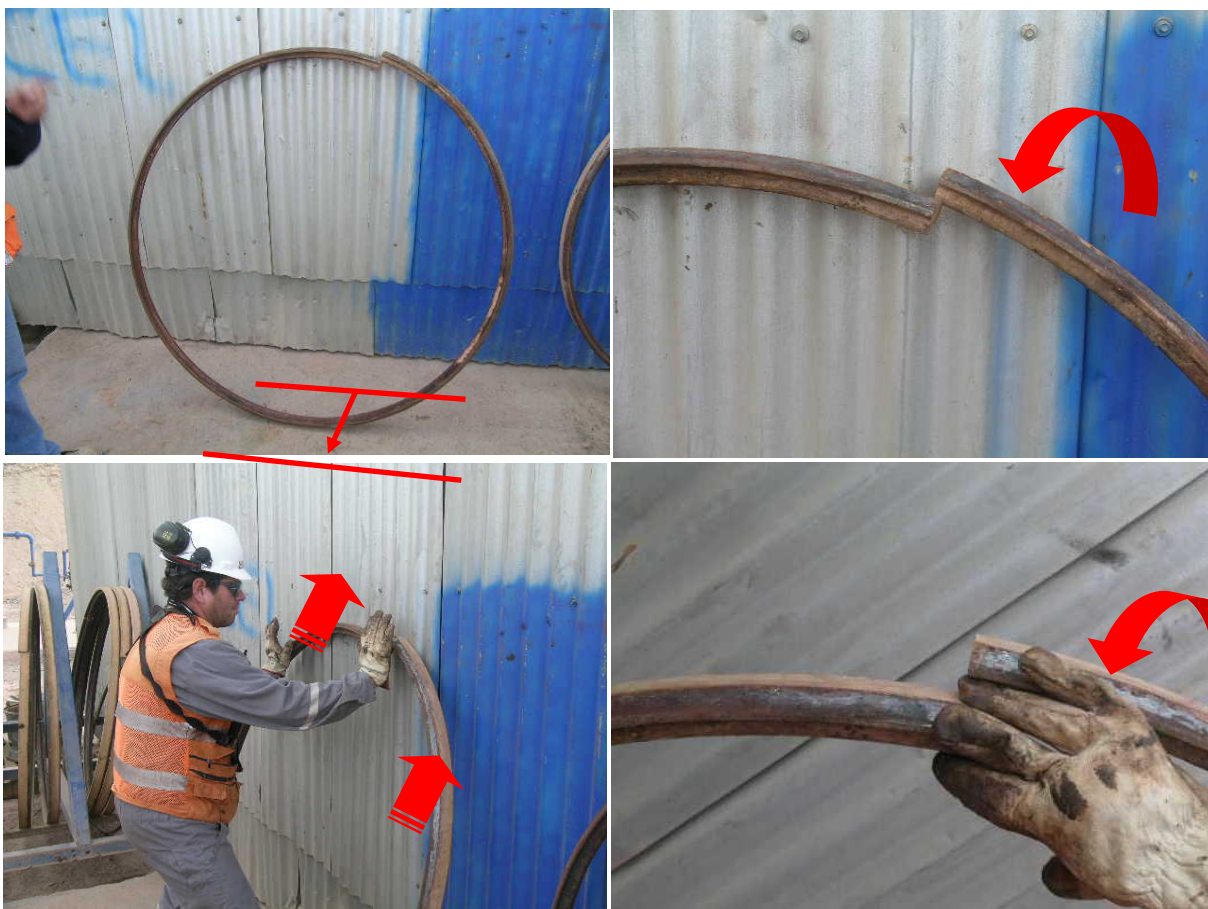
A tyre serviceman was preparing a lock ring for fitment and took it to the fitting slab to be cleaned. In securing it, he realised that the ring had been inclined. The tyre serviceman then grabbed the lock ring near the overlapped joint, which when he let it go, closed suddenly trapping his right hand ring finger.

The tyre serviceman was taken immediately to the site medical centre and later transferred to the local hospital where he was treated for a fracture to the first joint of his right ring finger. Local legislation does not permit any worker to return to work on a restricted work program, therefore the tyre serviceman was deemed totally unfit for work until he was certified as fully recovered from his injury.

- Incident reflection meeting with the rest of the workforce and implement immediate actions including:
  - Lock rings must be moved using two people as a minimum.
  - The lock ring must be placed flat on the ground to clean and prepare for fitment.
- Implement a plan for strengthening the use of Take 5's and safety observations.
- Revise the risk matrix and identify all hazards associated with handling lock rings.
- Evaluate other alternative methods for the movement and cleaning of lock rings.
