## Incident Notice

No 03-08, 20 Feb 2008

### Incident: Planetary Cover Damage

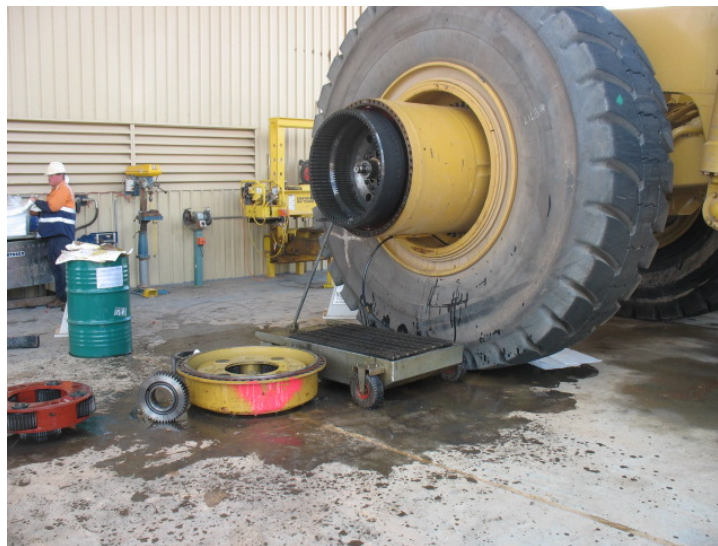
The tyre serviceman requested assistance to move a haul truck that was being worked on in the tyre bay. As the truck moved forward, the position 6 planetary drive cover released from its mounting and fell to the floor. Lubricating oil and several other gear components normally contained within the cover were also released and fell to the floor. During the release, the three retaining bolts sheared off. Nobody was injured.

Cat 785, 789 and 793 trucks use the outer wheel bolts to hold the cover in place against the hydraulic oil pressure. With the outer wheel off, there are only three small retaining bolts holding the cover. These bolts are not designed to withstand the hydraulic pressure if the truck is put in gear or driven.

The final drive axle can shear off the three small retaining bolts, allowing the hub plate to come off and consequently lose oil, shims and o-ring seals from the wheel hub.

The hub plate can be secured (without having to fit the outer wheel) by inserting a minimum of six wheel retaining bolts evenly spaced around the cover. The bolts will require sufficient spacers or washers of the same thickness as the nave (eg. a large nut) to secure to the hub plate.

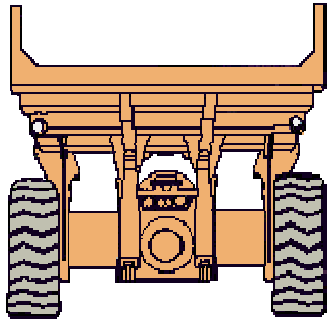
Correct way to move vehicle

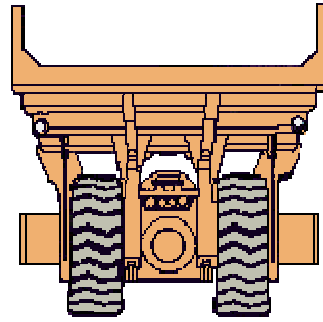
Do not place into gear or drive

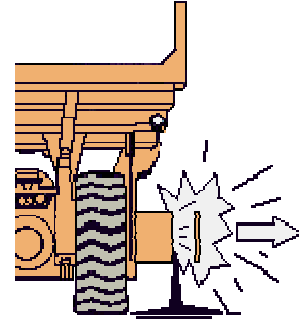
Planetary cover bolts sheared when in gear or driven

- Ensure that personnel are clear from direct line of fire when the truck is being moved.
- Release a safe work procedure to outline best practice.
