Incident Notice

No 54/07, 18 Feb 2008

Incident: Tyre Burst

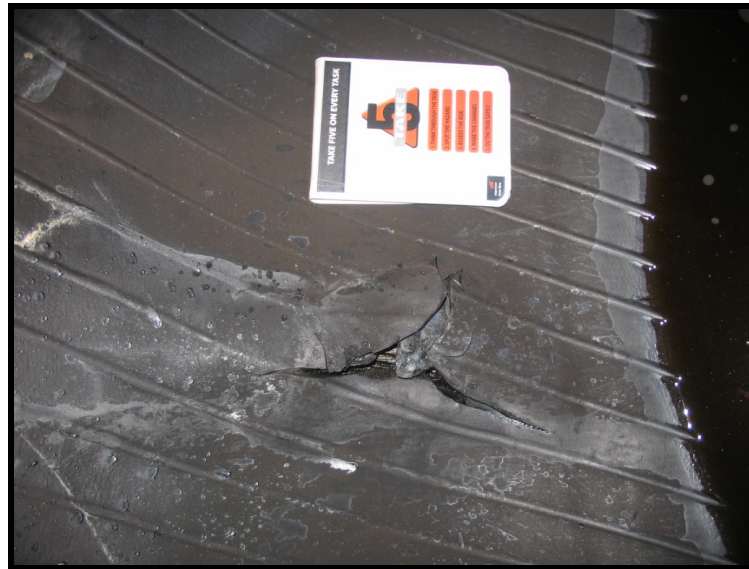
A split in the inner liner of the tyre allowed air into the structure of the tyre building up pressure until a weak spot is found to form a bulge which then burst. Refer to figures 1 and 2.

Figure 1: Split in the inner liner of position 3 tyre

- Reinforce to all operators the importance of pre-start checks and the immediate reporting of any defects.
- Review Otraco bubble procedure.
- Investigate the use of a tyre 'spike' that can be used to safely deflate any tyres found with a bulge in them and that can not be safely deflated by other means.

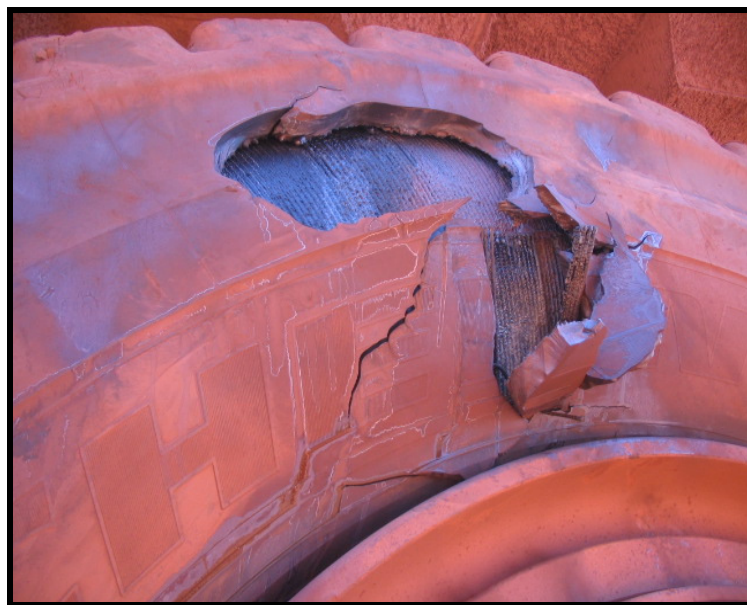
The tyre serviceman then continued checking tyre pressures on other trucks parked up in the area. Whilst checking a tyre on a truck parked to the left, there was a loud bang. It was realised that the position 3 tyre with the bulge had burst. A section of tyre sidewall was located 3 metres from the burst tyre. No injuries were incurred.

Figure 2: Sidewall of position 3 tyre where burst occurred
