MINIMISING THE FREQUENCY AND IMPACT OF TYRE FIRES AND EXPLOSIONS

Otraco (International) Pty. Ltd

October, 1997

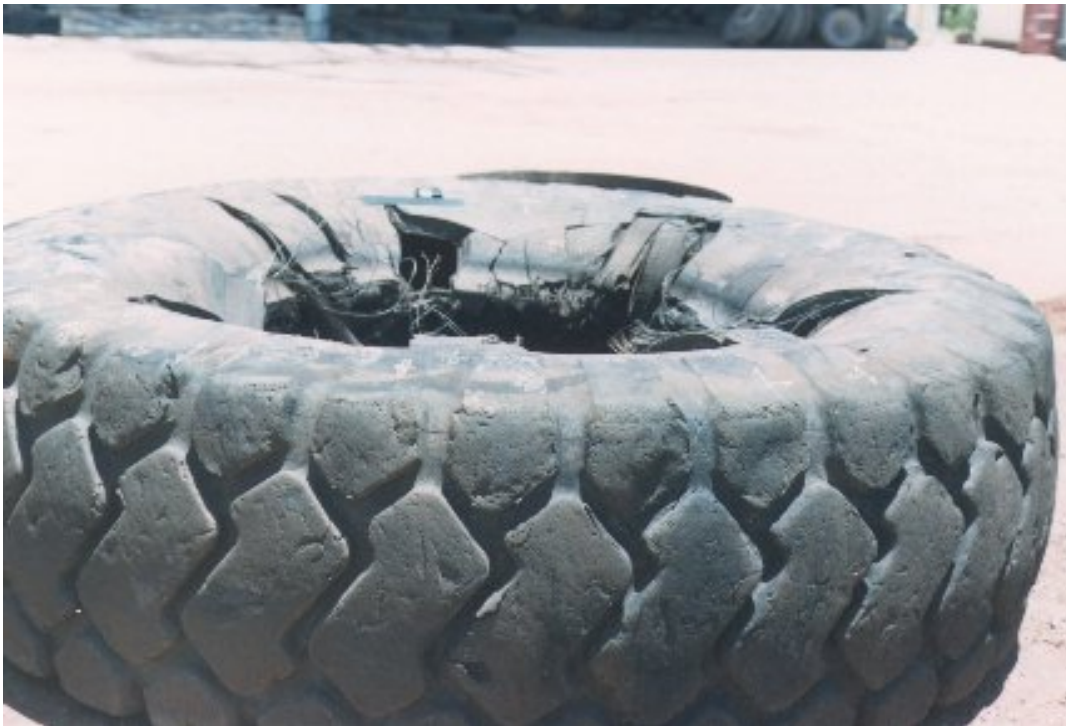
Figure 1 - An exploded tyre

One point that is often overlooked, is the potential for the maximum strength of the tyre to be significantly reduced before the explosion occurs. A new carcass may have a burst pressure of around 4500 kPa, but a damaged tyre may have the burst pressure reduced to 1000 kPa⁴ or less. This may be caused by fatigue, damage sustained to the tyre in normal operation, such as a casing repair, overloading or running over rocks, or the tyre may have been exposed to excess heat.

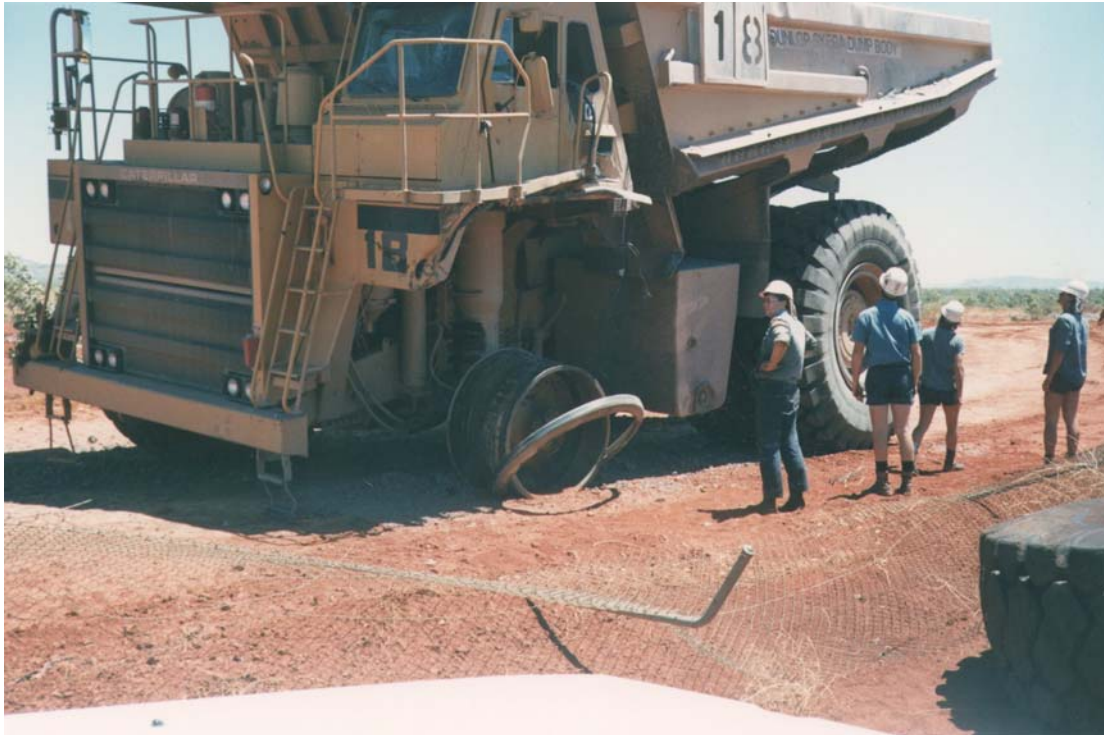
Figure 1 - Truck after explosion

A Cat 785 haultruck (33.00R51) was carting material from the mine area to a rehabilitation area. While pulling away from the tip point with its body up, the truck contacted 33kv overhead power lines. The driver braked to a stop and was advised to remain in the cab because the truck was still in contact with the power lines. The front left tyre exploded approximately 12 minutes later blowing the tyre and rim components off the truck, causing damage to the truck and minor injuries to the driver.

The exploded tyre was ruptured in the bead area of the outer sidewall (ie. the sidewall facing out from the truck); the bead bundle had completely sheared. There was no visible damage to the tread area or inner sidewall and bead. The inner liner was tacky from heat and a section of it had pyrolyzed. There was a small hole visible in the pyrolyzed zone. While the other five tyres appeared intact, the right rear tyre had a similar small hole in its liner.

The rim of the exploded tyre was extensively damaged. The truck suffered superficial damage mainly around and to the driver's cab. The left front wheel bearing showed signs of heat damage.

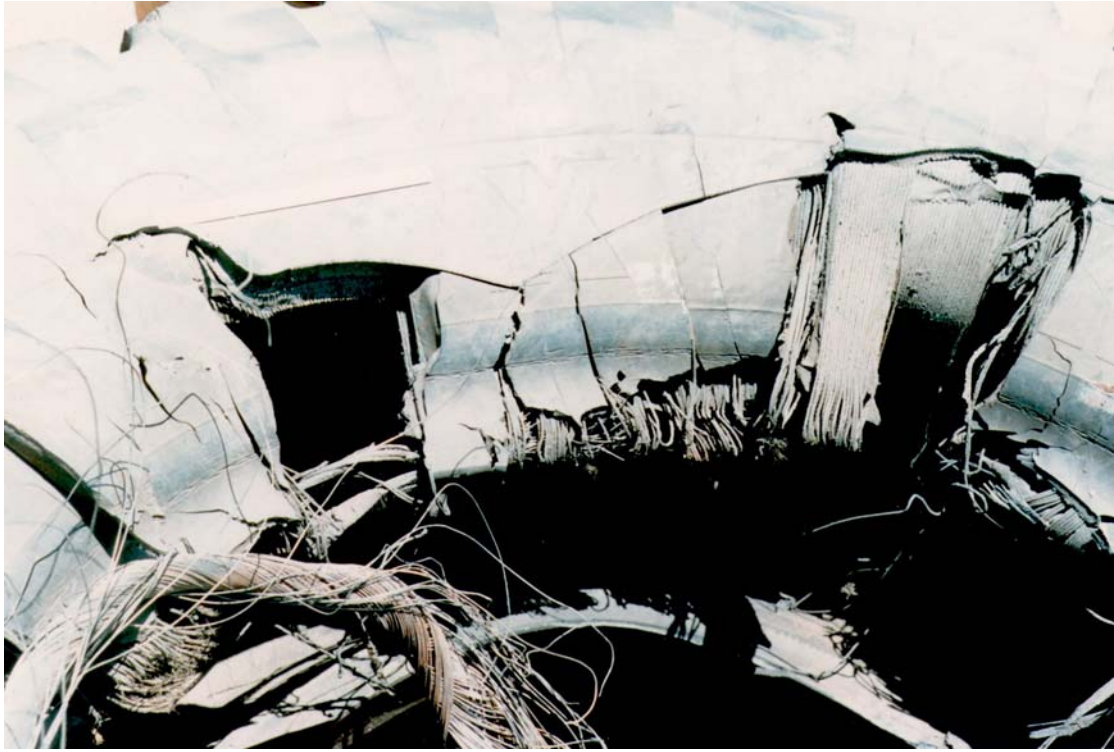
Figure 3 - The Damaged Bead Area

The failure mechanism of the exploded tyre was somewhat unusual in that the outer facing bead bundle was completely fractured by the force of the explosion, with the rupture appearing to originate in the bead area. Most earlier tyre explosions, for which Otraco has details, resulted in blow outs in the shoulder area at the edge of the circumferential steel tread breaker belts.

The bead bundle on this tyre is composed of twisted steel cable. One wire of approximately 1.8 mm diameter is wrapped a large number of times (in the order of 250) around a core strand of approximately 4.5 mm diameter. The bead bundle, which is 45 mm in diameter, appeared to have failed in tension with the strand ends exhibited cupping typical of this (tension) failure mechanism. There was no evidence of heat weakening of the steel strands nor of electrical arcing between the fractured ends of the bead bundle.

The force required to cause failure of the bead bundle would have been considerable and would have absorbed a significant amount of the total energy expended by the explosion. It appears likely that if the bead had not been fractured this energy could have been channelled into other areas, eg. additional damage to the truck, or expelling the tyre and rim components over even greater distances.

The majority of tyre damage was sustained by the outer¹⁷ bead and sidewall area. The tyre's tread area, and inner sidewall and bead suffered no external damage. The outer bead bundle (twisted steel cable of approximately 45 mm diameter) was completely sheared. Several large sections of the tyre's bead and adjacent sidewall had been blown outwards, hinging about the tyre's shoulder line but most remaining attached to the body of the tyre. Two large sections (greater than 500 sq. cm surface area) of bead and lower sidewall, and numerous small pieces of liner, bead and sidewall material, were blown off the tyre.

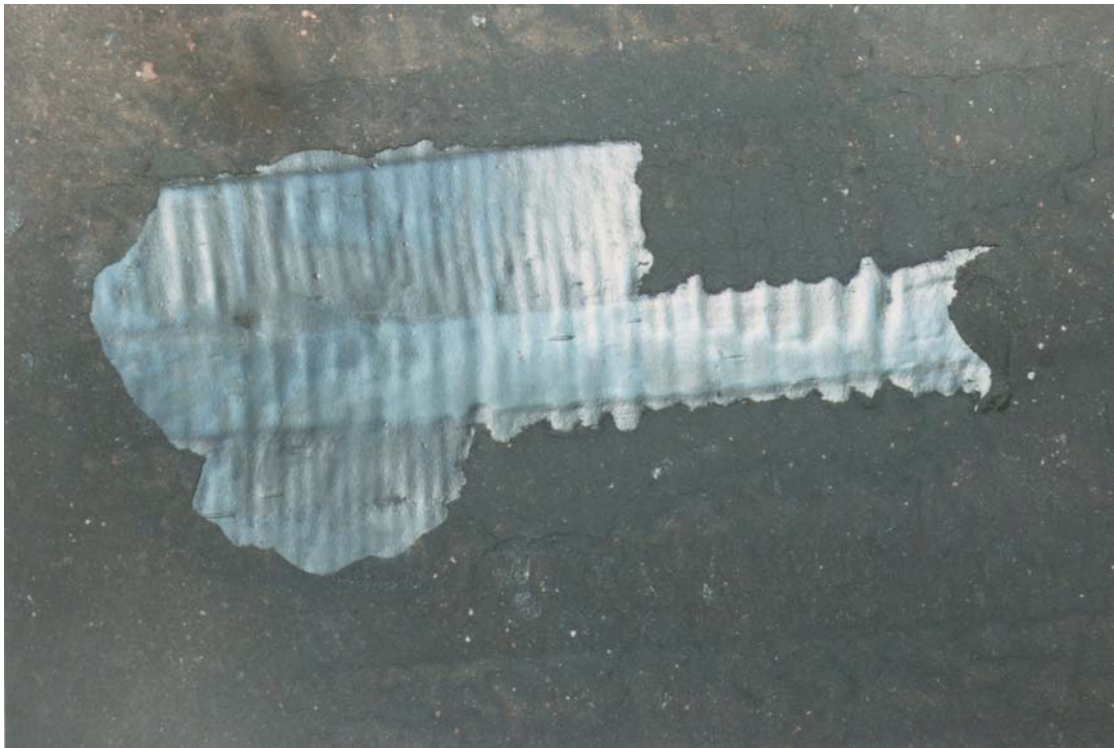
Figure 4 - Internal of tyre showing pyrolyzed area and arcing point.

The point at which the bead fractured was adjacent to the area of liner pyrolysis (the most probable explosion initiation zone). This is also unusual when compared with most explosions where the point of blowout has been almost diametrically opposite the pyrolysis zone (point of initiation).

Most of the tyre's inner liner showed evidence of surface heating, being either tacky to the touch or exhibiting a wrinkled texture. A 300 sq cm section of the outer liner layer¹⁸, approximately 1.5 mm thick, was missing (presumably pyrolyzed) from the crown of the liner. The exposed inner layer of the liner was in good condition showing no sign of heat degradation, apart from a small hole of approximately 6mm diameter and 1 mm depth which was apparently the result of electrical arcing. There was no evidence of arcing on the corresponding section of exterior tread crown, which had several small to medium sized rock cuts.

1. When the truck contacted the power lines it became electrified (fuses cut power to two of the phase lines, however the third remained live).
2. Presumably, at that instant (although possibly later) there was a sufficient buildup of electrical potential to cause electrical earthing through the position 1 rim and tyre²¹. This resulted in electrical arcing from a point in the crown of the tyre's liner through the tyre's casing and tread to earth. The arcing caused the small hole in the tyre's liner. Similar earthing and arcing occurred in the position 6 tyre (although not necessarily at the same instant) producing a hole in its liner as well. While electrical earthing may have occurred through other tyres on the truck as well, no evidence of arcing was found in these tyres.

4. Approximately 12 minutes after the truck hit the power lines, the tyre exploded. Presumably, the two conditions necessary for an explosion prevailed at this time:
 - i. the formation of an explosive mixture of gases due to pyrolysis of a sufficiently large amount of liner material, and
 - ii. a buildup in hot spot temperature within the air chamber equal to or greater than the auto-ignition temperature of this explosive mixture (around 430°C).

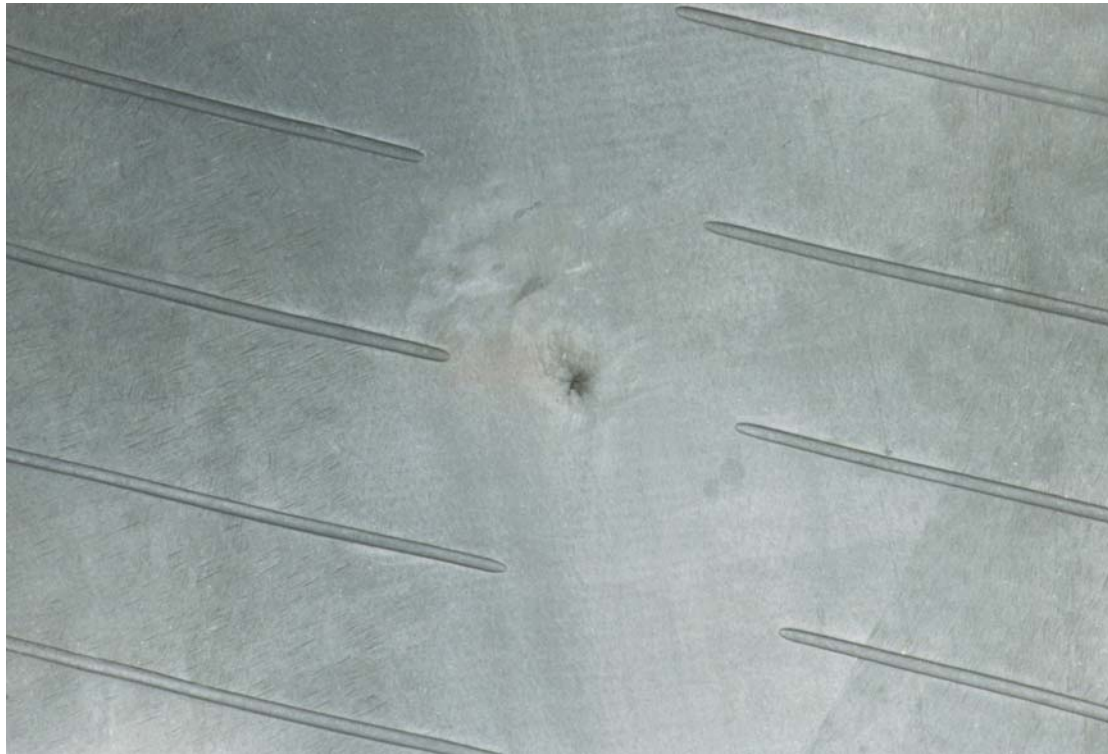
Figure 6 - Arcing hole on Position 6

The position 6 (right outside rear) tyre had a hole in the crown of the liner similar to the hole observed within the area of pyrolyzed liner of the tyre which had exploded. There was no tackiness around this hole nor any other sign of heat or damage inside the position 6 tyre. The corresponding section on the exterior of the tread had a medium sized rock cut. The tyre had an average 56 / 59 mm of tread remaining (31% worn).
